Preserving Haiti's Gingerbread Houses

2010 Earthquake Mission Report

**2010 Earthquake Mission Report
December 2010**

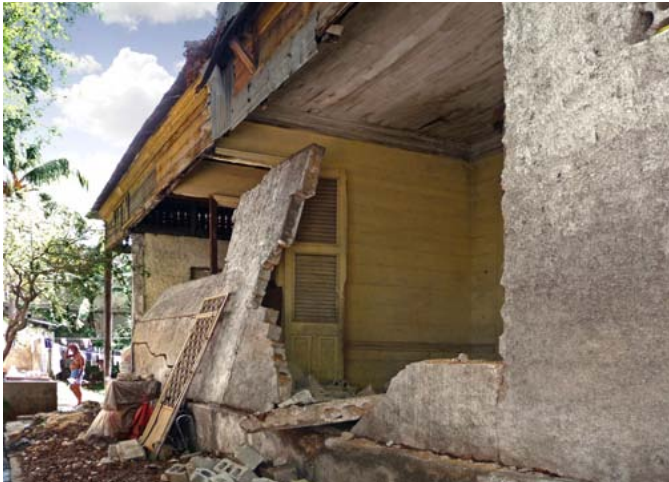
FIGURE 72 A replacement side wall of concrete block at 19 Lamar-tiniere suffered partial collapse.

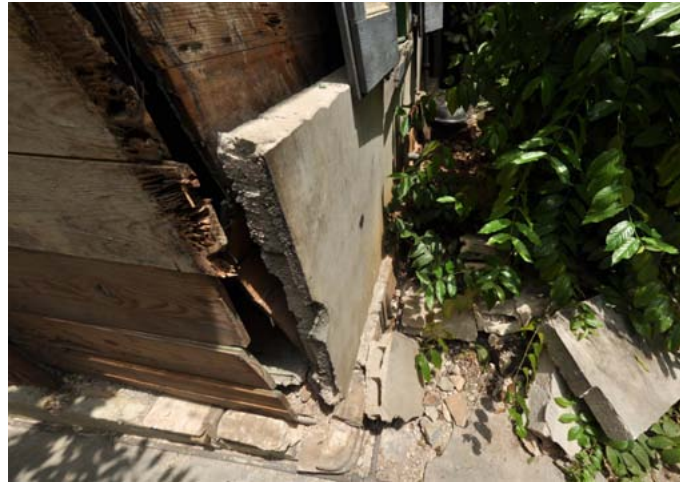
FIGURE 73 These are examples of *colomage* where the rubble infill has been replaced with concrete. This has accelerated the rotting of the timber framing, which then broke during the earthquake causing the collapse of the heavy concrete infill.

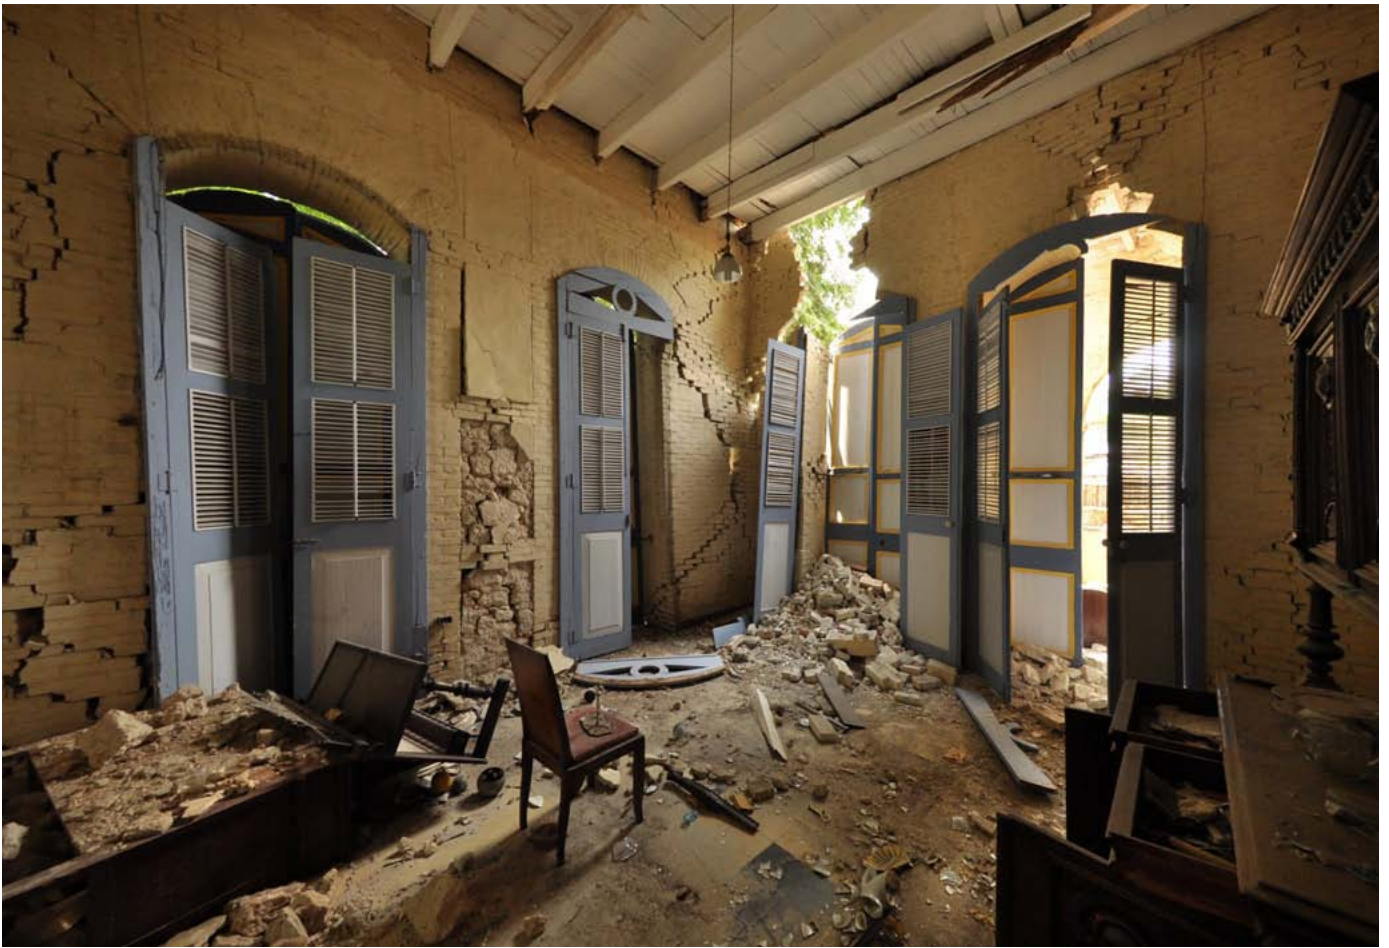
FIGURE 97 Two-story masonry house at 46 Avenue Christophe. During the earthquake, part of the second floor collapsed, followed by the subsequent collapse of the rest of the second floor. These photos show the ground floor, which remained standing, but with major rupture to the masonry walls, particularly at the corners. *right* The iron rod that had held the building together at the floor level is visible where it had failed because of corrosion. This image also reveals how the inner wythe of brickwork was not bonded to the outer layers of rubble stone. To form the inner corner of the room there is a layer of brick, whereas in the middle of the room, the rubble stone panel goes through the entire thickness of the wall.

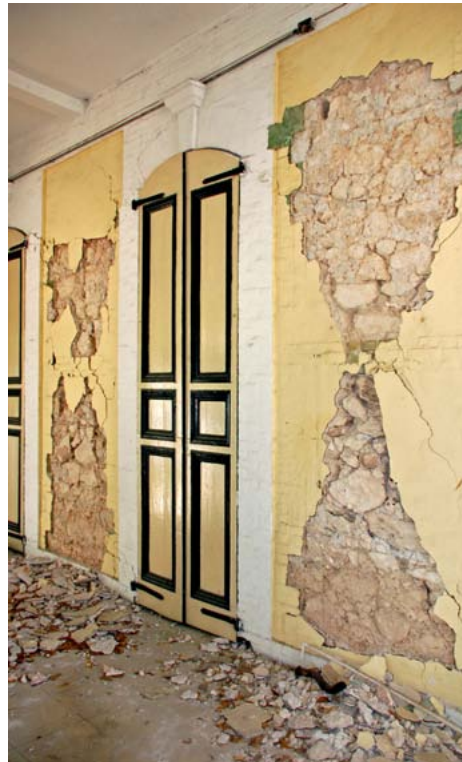
FIGURE 115 The characteristic X-cracks seen on masonry wall infills of concrete frames are also present at Le Manoir. These are due to the reinforced concrete second floor slab (above the damaged wall in this picture).

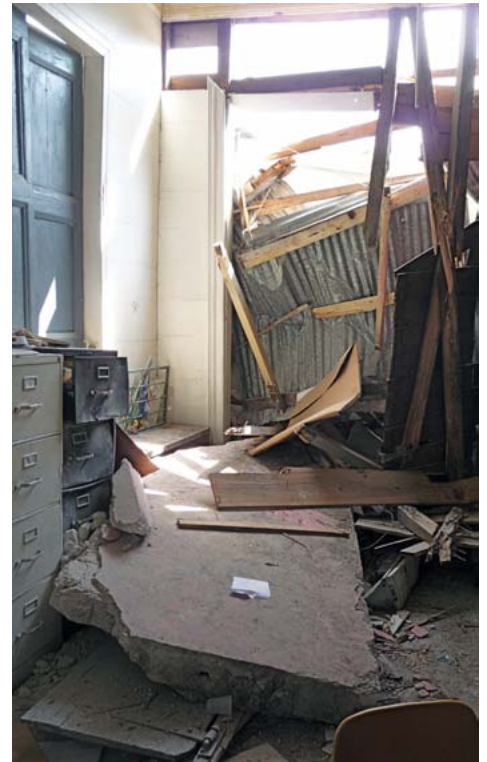
FIGURE 116 The most damage this Gingerbread suffered was from a concrete slab ejected through its back door from the collapsed concrete building behind. The building's front porch roof was also damaged, by a collapsed concrete building to its side (see Figure 82, page 40).
