Assessment of Rohingya Emergency Shelter Efforts May-Sept 2018

Report + Photography: Kevin Rowell, November 21 2018

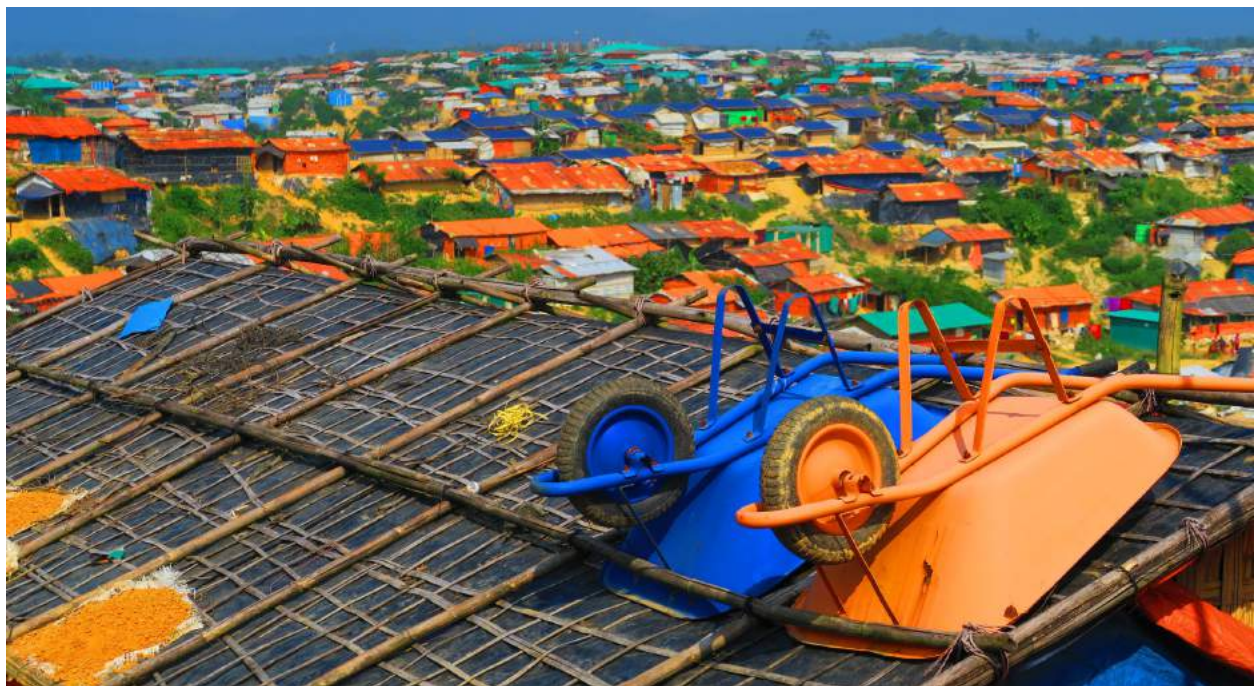
Communal tools sit on top of a shelter's roof while not in use. In the distance various colors of tarp roofs dot the landscape.

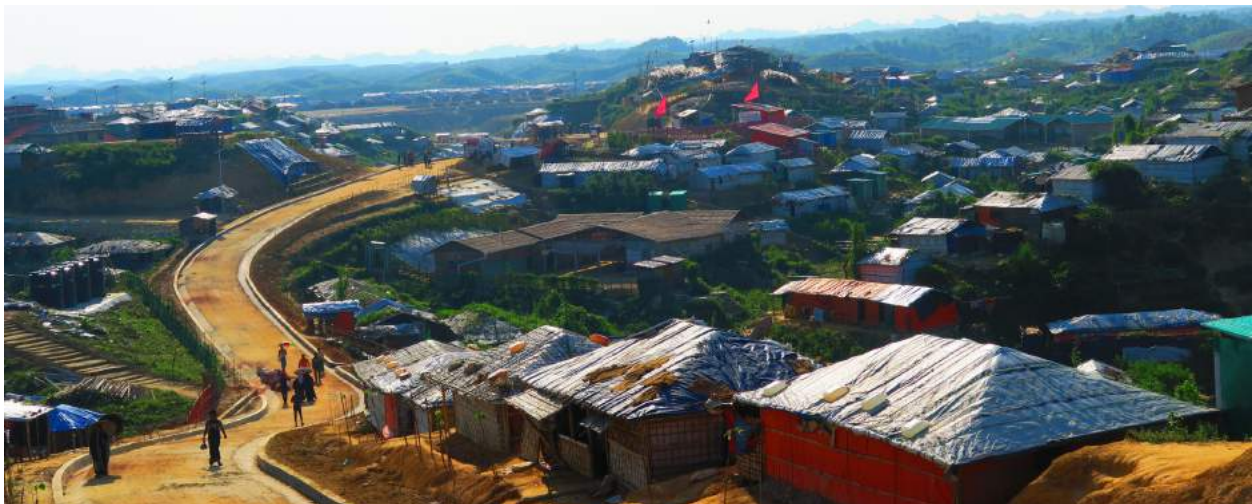
Critical infrastructure like roads, drainage systems, potable tube wells, toilets, showers, stairs and bridges have been installed to assure accessibility, hygiene and general population safety.

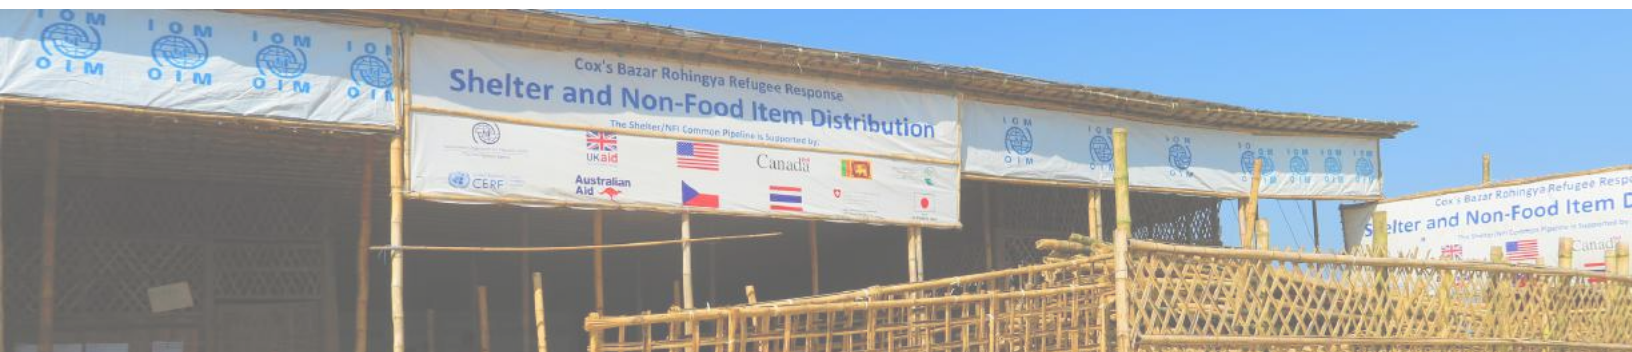
A Non-Food Item (NFI) Distribution center is pictured. The vast majority of structures in the camps are made of bamboo.

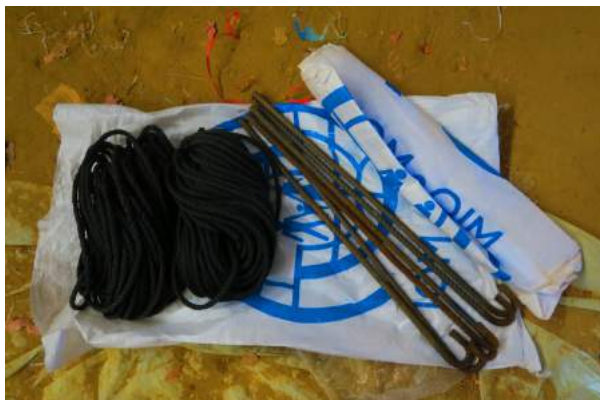
Tie-down Kits were supplied initially to help further support the emergency shelter provisions and their resistance to monsoon season. They typically consisted of rope, metal rebar stakes, and sandbags.

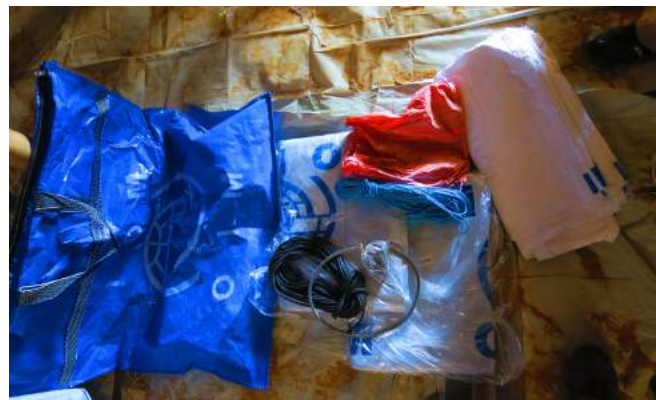
Upgraded Shelter Kits released in December, 2017 contain rope, wire, nails, tarps, sandbags, and as available an allocation of 4 Borak and 60 Mulli-Bamboo.

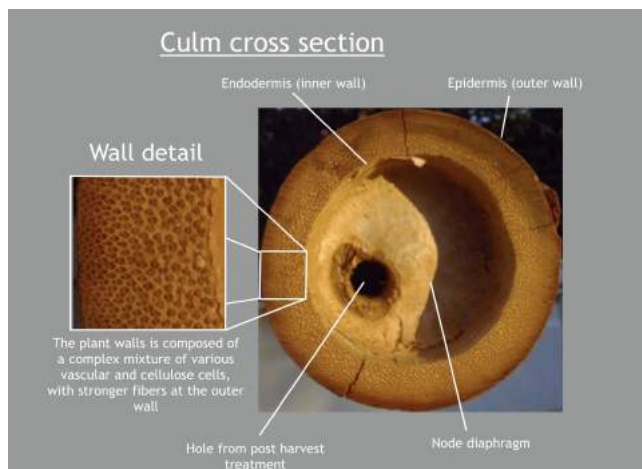
This image details the physical structure of the inner portion of a bamboo culm.

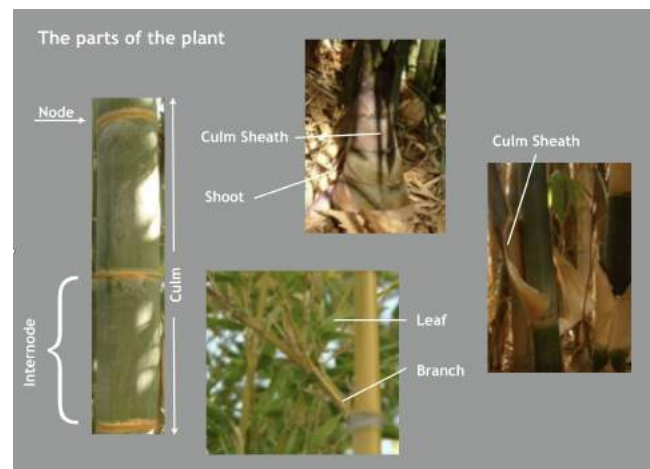
This image details the physical structure of the outer portion of a bamboo culm.

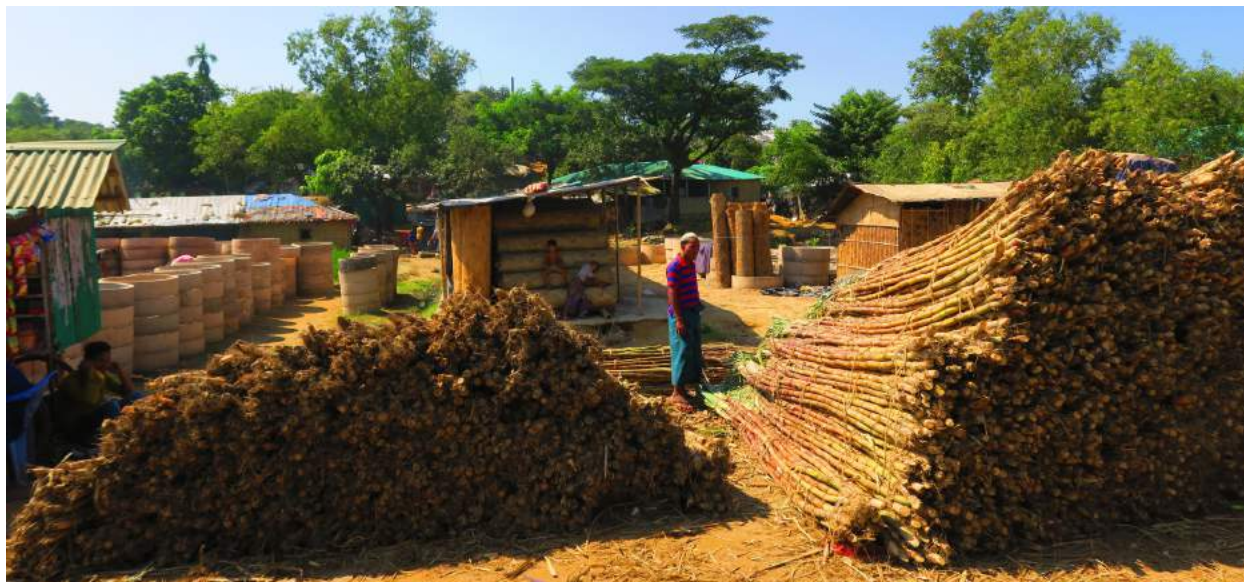
A local vendor is seen looking over a recent shipment of bamboo. Numerous vendors such as this exist outside the camp in the surrounding areas. They sell poles to the general public and serve as an informal secondary market for materials.

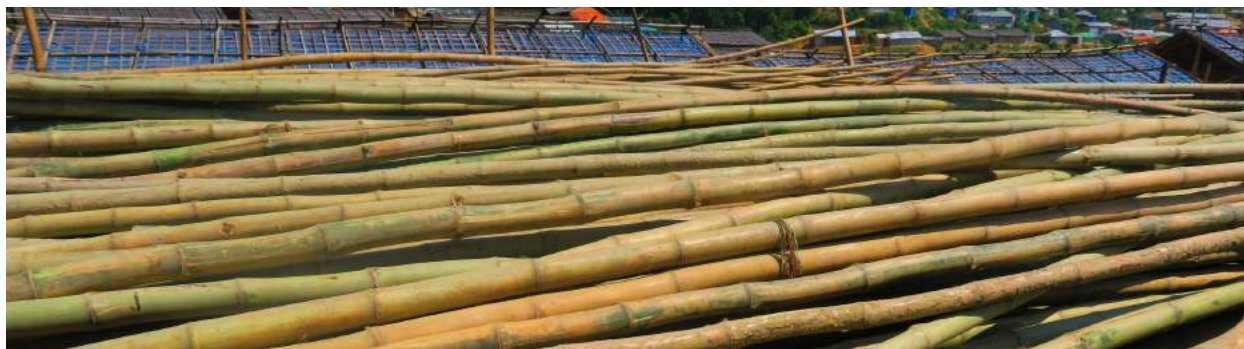
Borak - Bambusa Balcoa - This load of around 300 poles was dropped in a camp distribution yard in Camp 4 on the day of one of our visits.

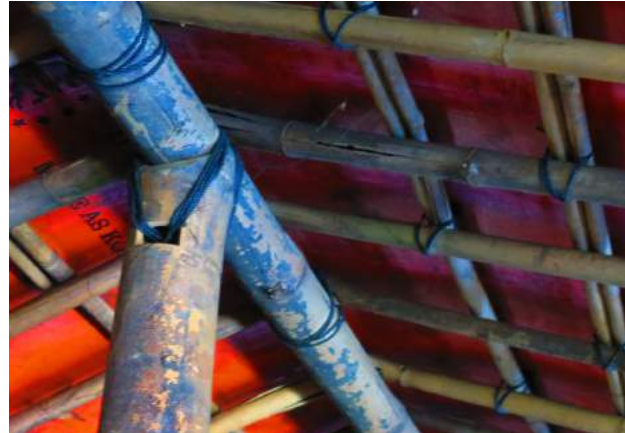
A typical pillar to ridge beam connection, demonstrating consistent and quality craftsmanship.

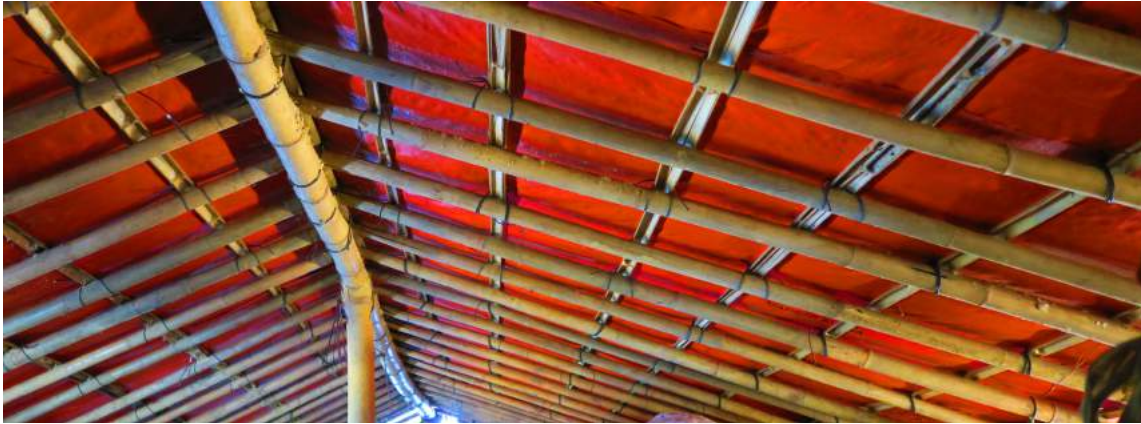
Method A: The purlins provide the primary support of the roof tarpaulin. In this variation the purlins are split Mulli bamboo with the cun side down, lashed to and supported by the bamboo rafters.

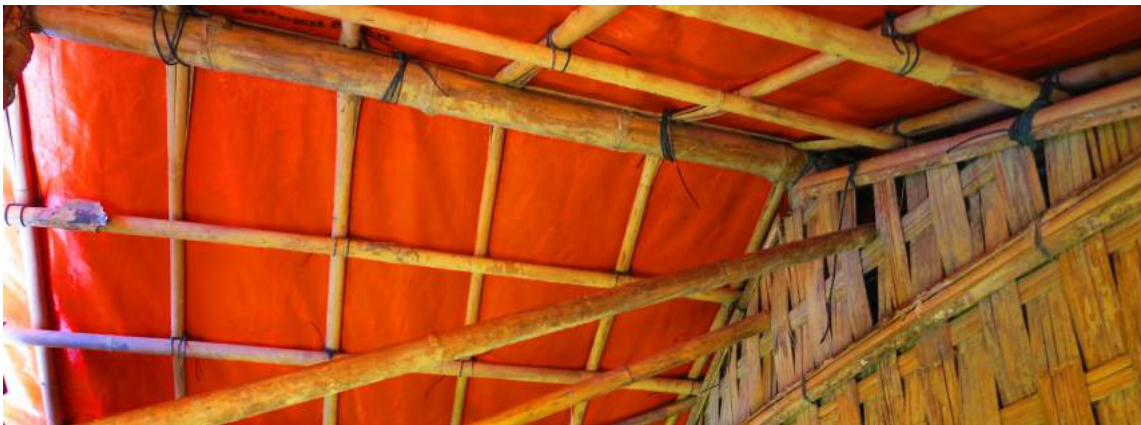
Method B: The bamboo rafters provide the primary support of the roof tarpaulin. This reduces potential for rainwater pooling because any draping of the tarp slopes continuously to the eave. The purlins are whole round Mulli bamboo, and

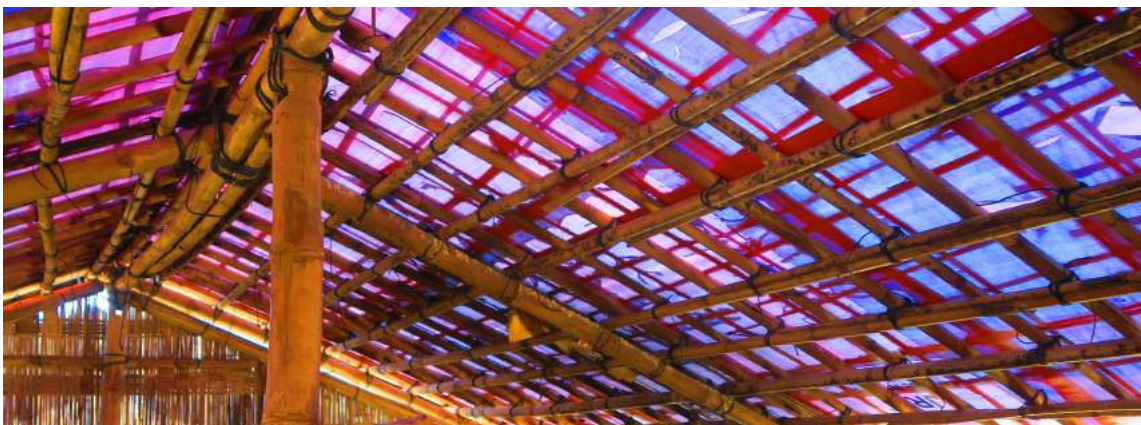
Method C: 4 to 5 Borak bamboo primary rafters are larger diameter and are spaced farther apart than in Methods A and B. Full round horizontal bamboo purlins are supported by and lashed to those rafters. An additional layer of sloping bamboo purlins run from ridge to eave, lashed to the horizontal purlins. This is a stronger system for downward loads, but reduces the distribution of wind uplift loads to fewer points – only where the fewer primary rafters are tied to the tops of the walls.

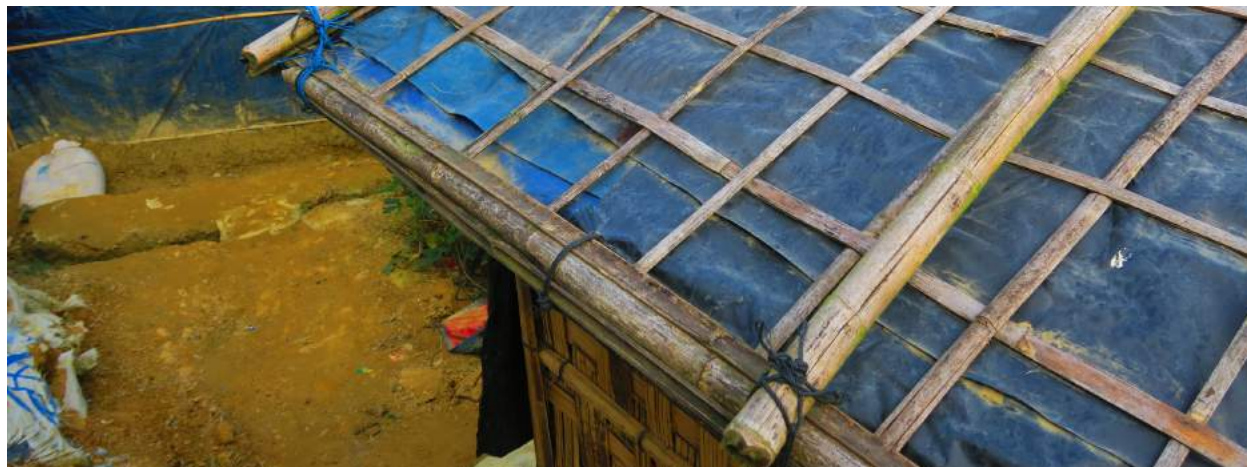
This exterior view of the roof edge shows typical exterior battens, rafters and roof edge lashings, all of which protect the tarp from wind damage.

- The most critical connections to maintain will likely be the roof edge where upper rafters are bound to the roof edge as the tarp membranes are the most susceptible to wind damage at these points. An education campaign is recommended to help assure that beneficiaries are able to monitor and repair roofs as wind loads increase in the cyclone season.

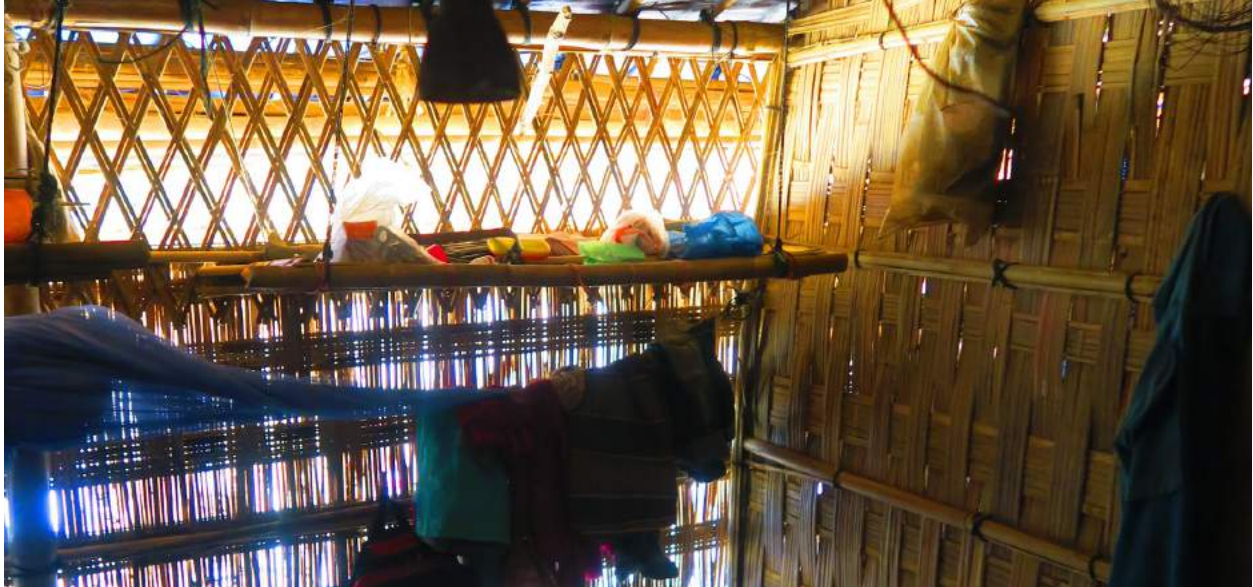
The interior of this home shows the same wall panel construction when observed from direct exterior light on the lower left wall section and indirect interior lighting on the right wall section. Gaps or space in the wall weave can appear larger from a distance due to the lights refraction as it passes through the wall, close physical inspection is required to verify quality.

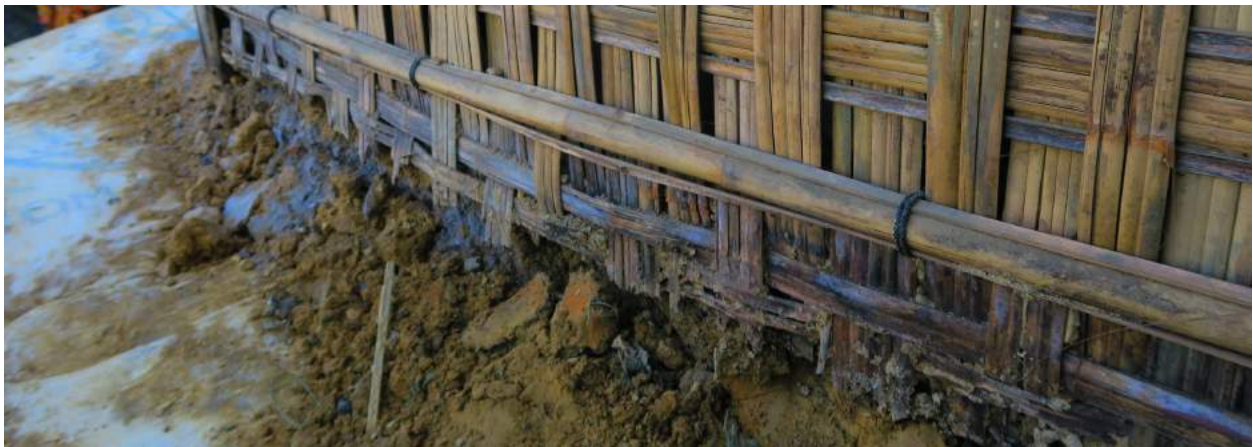
Most of the panels observed have direct soil contact along the base of the walls. This adds structural rigidity to bottom of the panel but also increases exposure to moisture and insect damage.

Damage has occurred from this wall panels direct contact with the earth. A combination of moisture wicking and insect damage has traveled through the lower 6 inches of the wall.

- For instances where insect presence is minimal, spraying a borax liquid solution especially on the exposed inner wall panels could slow and deter deterioration.

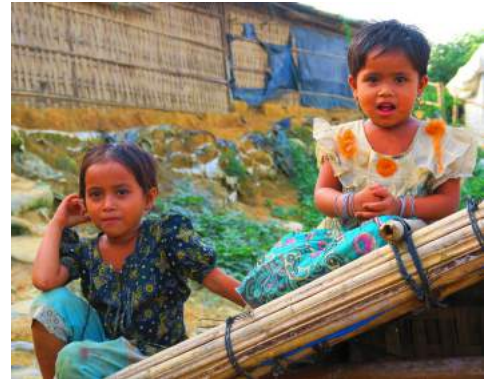
Children sit on top of a roof watching the neighborhood below. It was common to see children and adults walking on their roofs.

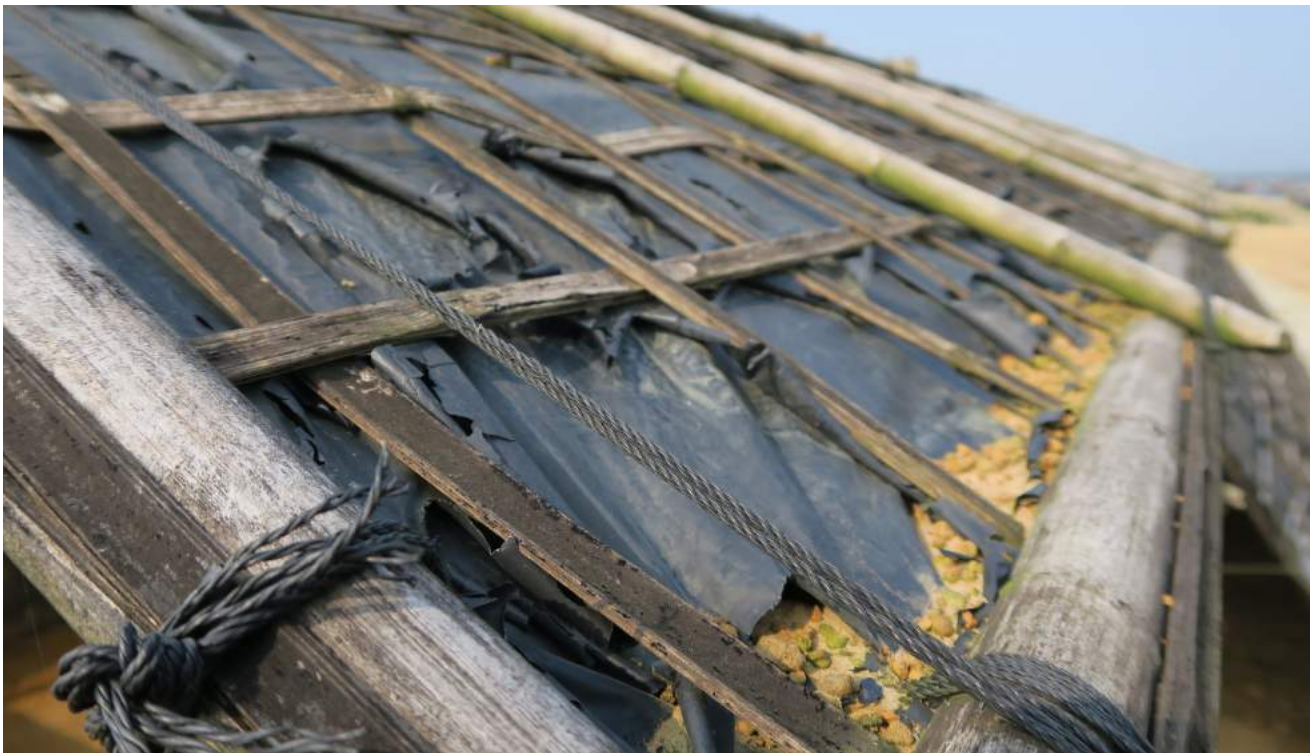
A close up of a roof shows the deterioration to the top layer of black plastic, the small amount of earth on the bottom edge is washed down from a sandbag put on the roof during the rains. The sandbags helped to reduce the uplift on the membrane during winds. This is an owner implemented innovation.

- The top layer of roofing grid in many instances is already showing severe UV deterioration, these would best be addressed before they become broken and then pose added risk for puncturing the membrane.
