Preserving Haiti's Gingerbread Houses

2010 Earthquake Mission Report

**2010 Earthquake Mission Report
December 2010**

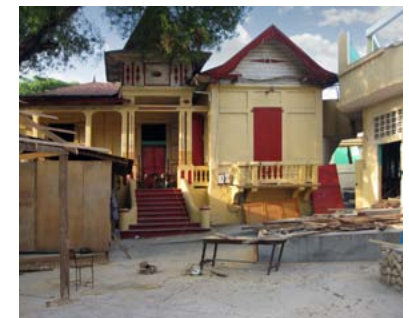
FIGURE 30 Concrete frame/confined masonry Gingerbread. This is the only variant of this type seen. It was undamaged.

FIGURE 29 The east (back) elevation of the Villa Castel Fleuri on Avenue Christophe, a grand brick and rubble stone masonry house. This house was occupied by the President of Haiti for a short period in its history. It has suffered extensive damage in the earthquake mainly to the projecting stair tower on the east side, and porches on the west. The plates that hold the iron ties that penetrate the building are visible on the façade. See also Figure 47 on page 29.

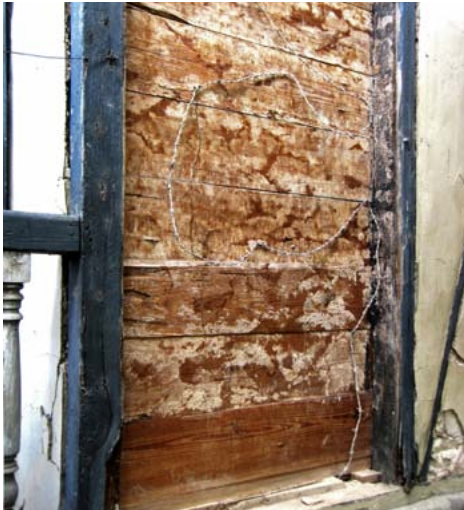
FIGURE 40 In this *colombage* construction the stone infill has collapsed due to the earthquake revealing the barbed wire reinforcement. This is an example of a non-construction material being adapted for construction due to its apparent availability. The barbed wire was galvanized and is still in good condition.

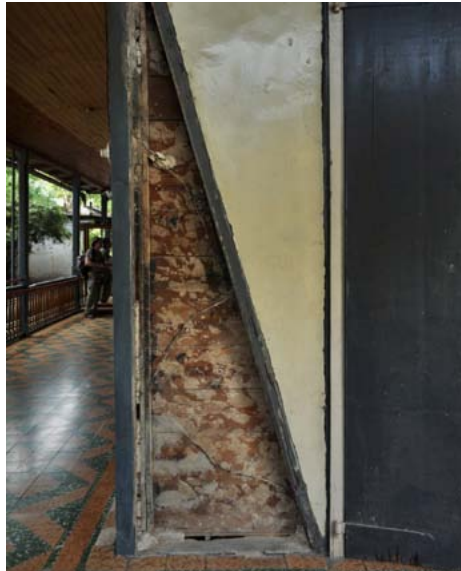
FIGURE 41 House at 15 Rue M showing plastered rubble stone infill. On the left, one panel fell out in the earthquake, revealing that it was reinforced with barbed wire inserted into the bay in a zigzag layout.

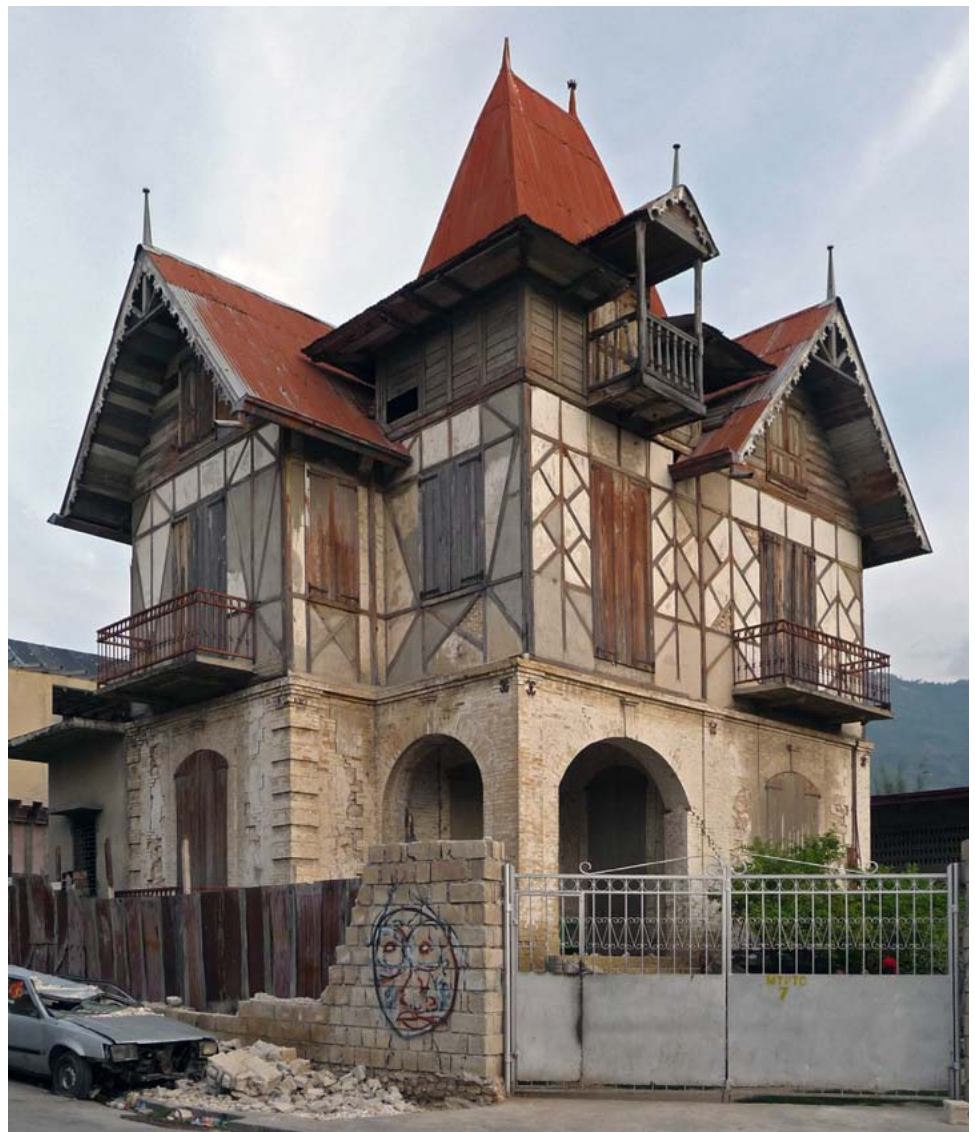
FIGURE 49 Hybrids are very common. This Gingerbread house at 59 Lavaud 3 utilizes all three wall-construction systems:
Attic walls—wood frame
Second story—colombage
First story—masonry bearing wall
 Note also the one-story concrete addition at the back left corner.

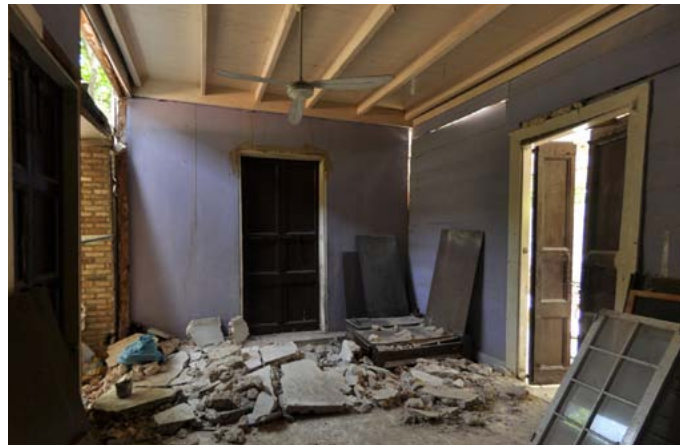
FIGURE 74 Improper repair of stone infill of *colomage* using concrete. These repairs constitute a fill that is much stiffer and more cohesive than the fill it replaced.

Use of cement and concrete to repair/replace rubble stone infill: In many places where rubble stone infill panels on *colomage* walls were previously damaged or required repair, it was either consolidated with Portland cement mortar or the fill was removed altogether and reconstructed with concrete infill or concrete block with cement mortar (Figure 73). These repairs constitute a fill that is much stiffer and more cohesive than fills using traditional materials, which results in detrimental performance of the system in an earthquake (Figure 74). In some instances houses that had been repointed with cement showed wear in the cement pointing possibly related to its incompatibility with the underlying lime/sand mortar.

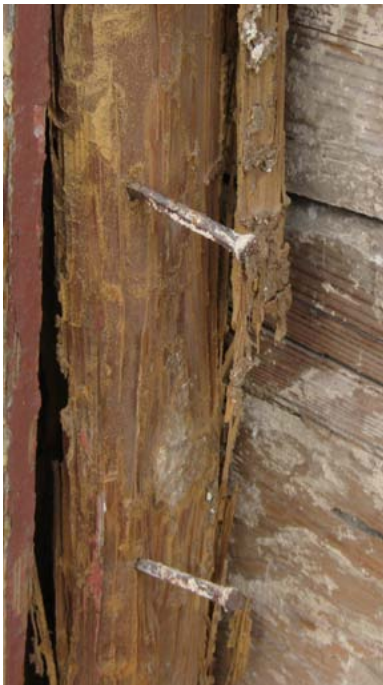
FIGURE 84 Despite extensive termite damage, the remainder of this post is hard and dense, still holding the nail firmly.

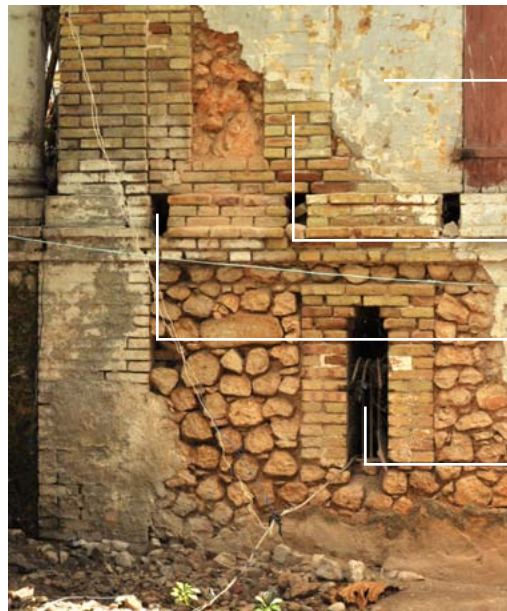
The finished plastered wall surface hides the substrate material from view. Years of rain and lack of maintenance have caused erosion on the building revealing the structure

Pockets for the floor beams; in many instances the ends of the beams showed extreme rot.

FIGURE 92 Basal erosion of the wall surface and foundation.

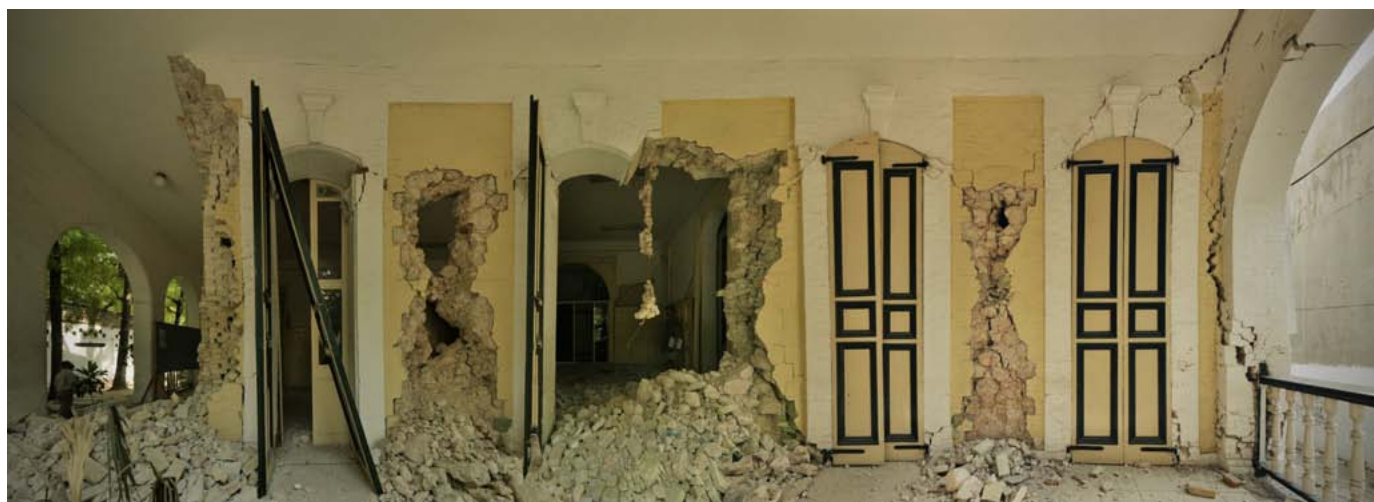
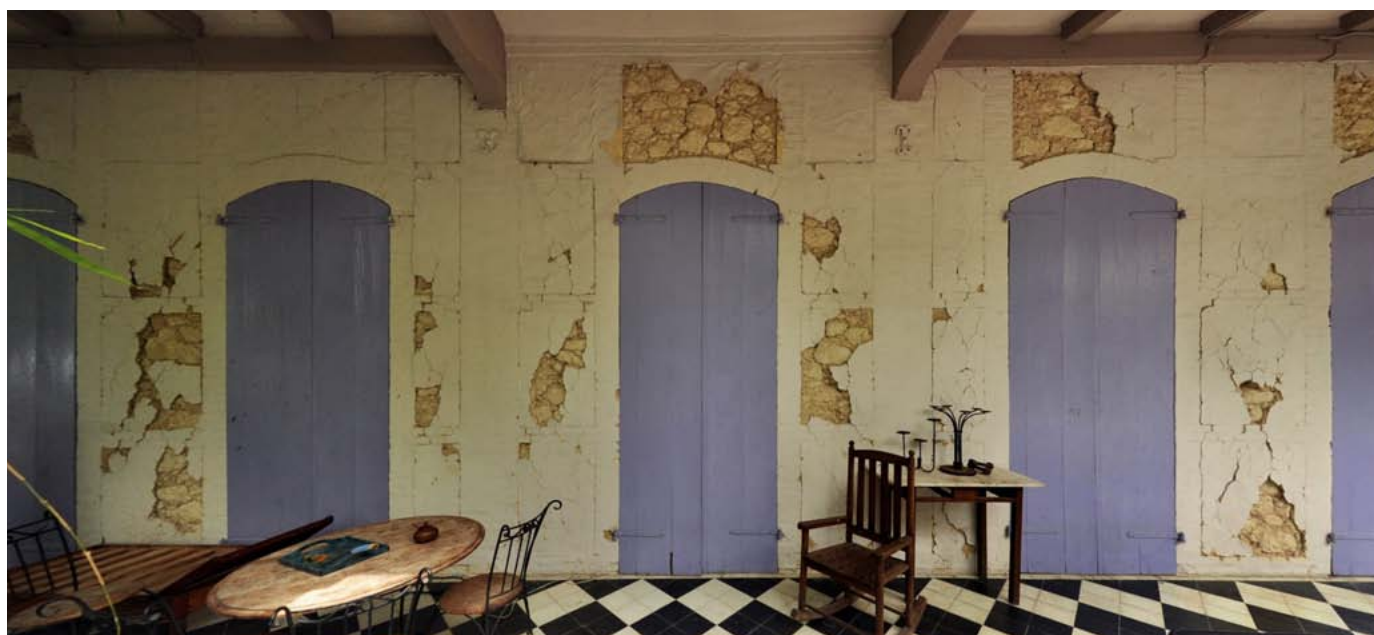
In a number of instances where the rubble stone panels were fully degraded or collapsed, the buildings (such as the Dufort House and Le Manoir) were saved from total collapse by the brick piers that surrounded and confined the rubble stone (see Figures 95 and 96). Unfortunately, this brickwork was not bonded one wythe to the

FIGURE 96 *top* Exterior view of Le Manoir on Avenue John Brown. *middle* interior view of Le Manoir showing a fully disrupted ground-floor wall where the rubble panels have collapsed, but the buildings remained standing on the brick piers. (view is a mosaic of several photos connected together). *bottom* House at 65 Avenue N showing infill panels manifesting the onset of damage, but little displacement during the earthquake.

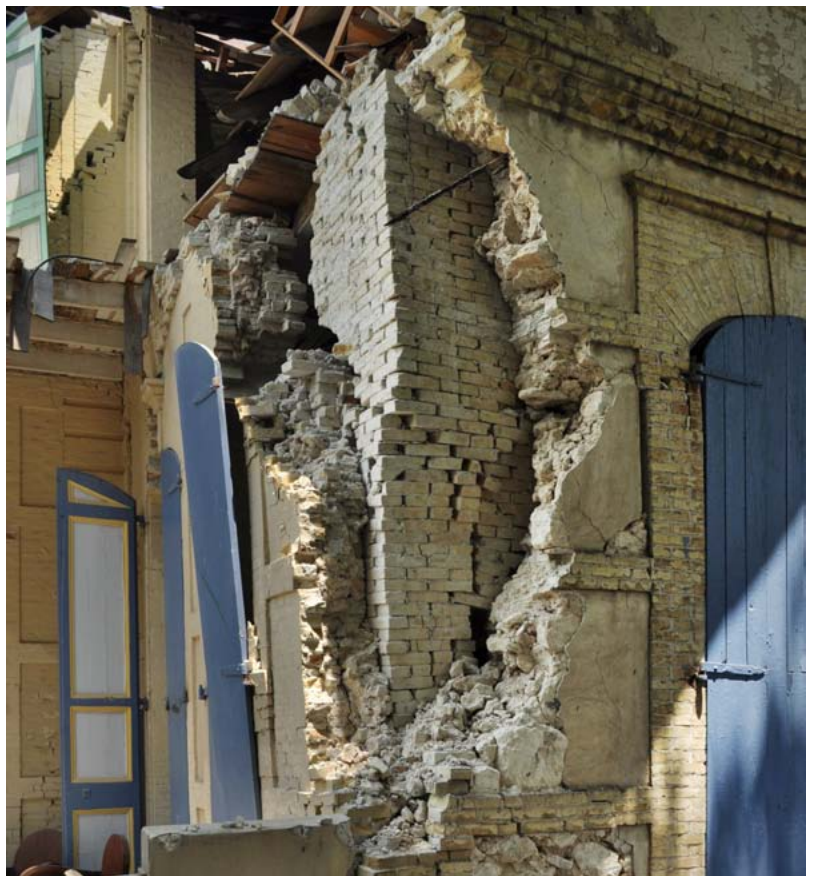
FIGURE 97 Two-story masonry house at 46 Avenue Christophe. During the earthquake, part of the second floor collapsed, followed by the subsequent collapse of the rest of the second floor. These photos show the ground floor, which remained standing, but with major rupture to the masonry walls, particularly at the corners. *right* The iron rod that had held the building together at the floor level is visible where it had failed because of corrosion. This image also reveals how the inner wythe of brickwork was not bonded to the outer layers of rubble stone. To form the inner corner of the room there is a layer of brick, whereas in the middle of the room, the rubble stone panel goes through the entire thickness of the wall.

next, so the piers have been shifted in those locations where rubble has been heavily disrupted or collapsed (see Figure 97). However, because of the horizontal bedding of the masonry, they remained stable. Walls that were disrupted to this extent will need to be rebuilt, and when rebuilt, a more stable masonry can be substituted for the rubble masonry. Since the rubble was always in recessed panels covered with plaster, substitution with better material should not result in a visual change.

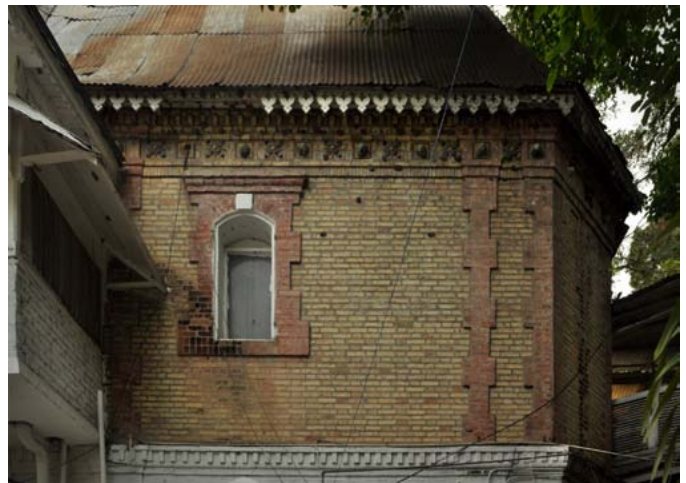
FIGURE 100 left First-floor porch of the Hotel Oloffson showing brick façade with the many door openings that surround the building on all sides. **right** Typical brickwork where it can be seen without the porches.

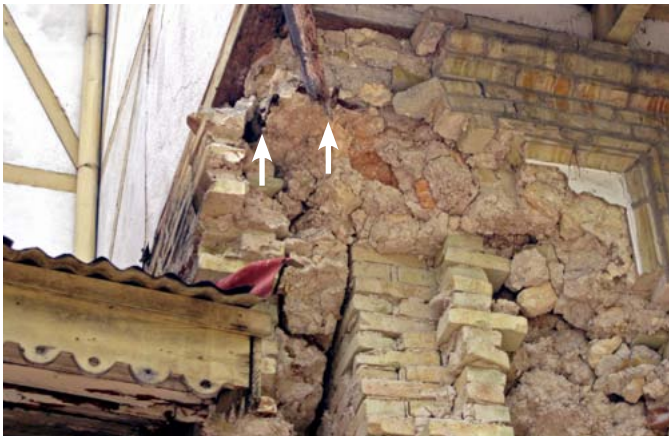
FIGURE 103 Embedded tie rods cross at the corner, anchored by iron bars. Also note rubble fill between inner and outer leaves of brick masonry.

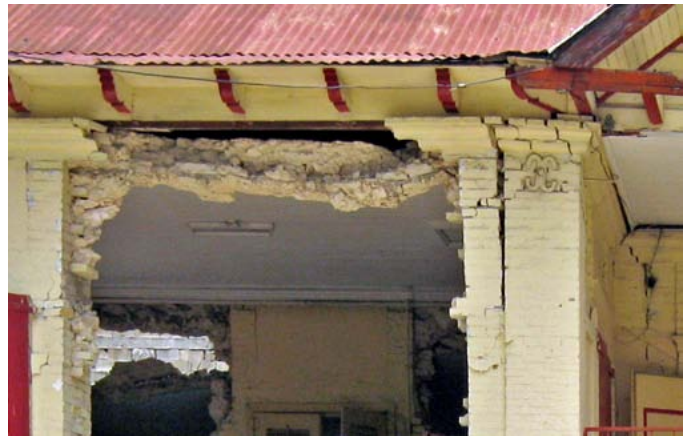
FIGURE 104 Total collapse was avoided in this heavily damaged masonry building due to embedded iron rods at the top of the walls, with exposed end plates.

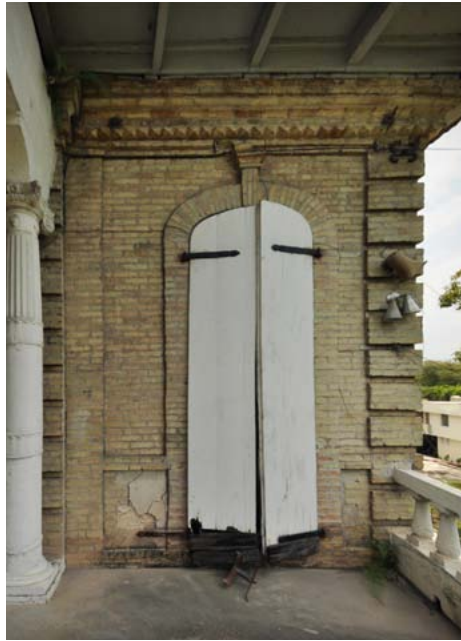
FIGURE 107 112 Rue La Fleur Ducheine, showing the metal plates at the end of the iron chains that are laid into the walls at the floor level. The end of the second floor wall on the left suffered damage because the plate around the corner to the left had fallen off probably because of rusting of the rod, whereas the plate on the right hand corner of the same wall shown on the right was intact, and thus the earthquake did not damage the wall at that end.

failed from rust or were not installed at the time of the building's construction, their failure/absence was associated with a greater amount of damage and disruption of the masonry (Figure 107). One good example is the Villa Castel Fleuri, where for an unknown reason rods were not installed at the corners of the second floor, but were installed at the first bay location and at the roof level. In this instance, the second floor corners were more dislocated by the earthquake than were other parts of the building where rods were present (Figure 108 and 47).

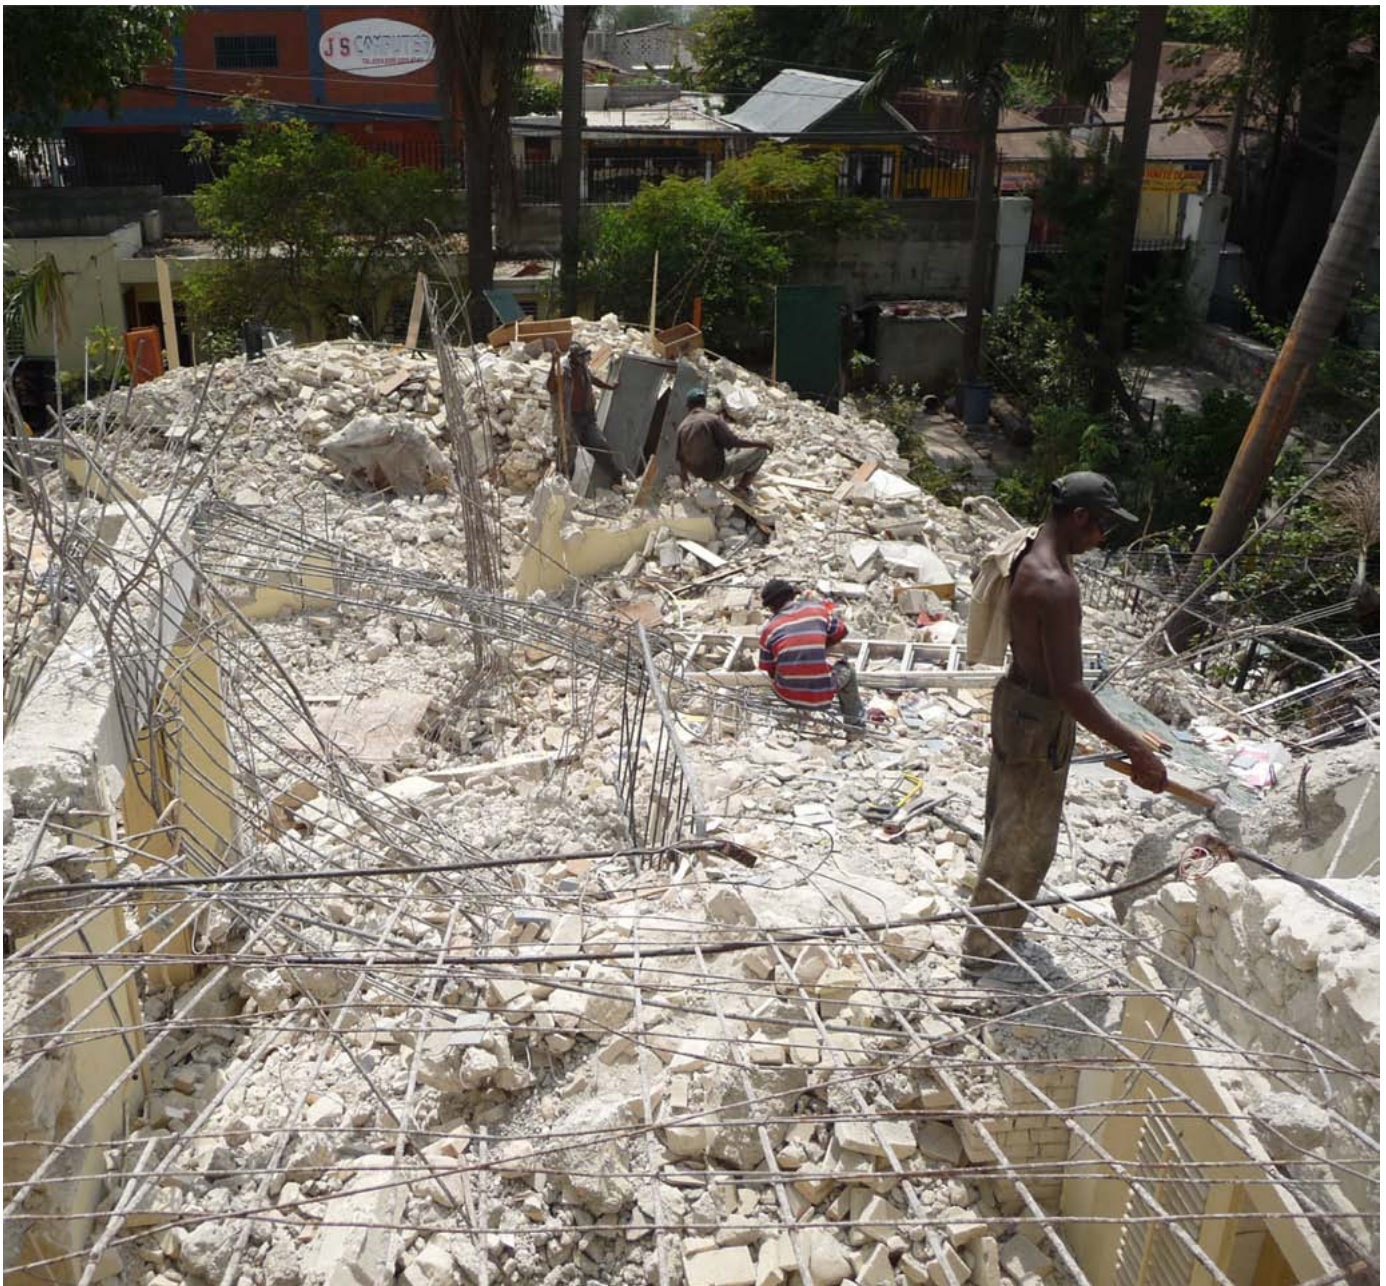
FIGURE 118 In a typical scene, a Gingerbread stands intact beyond the tragic collapse of a modern concrete building

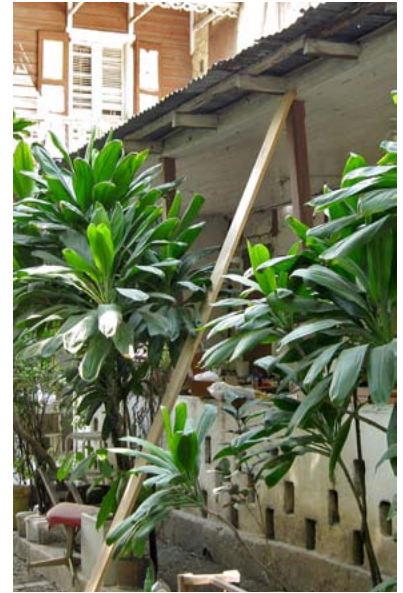
Team members observed that the shoring in place during the April mission was often under-structured and not configured correctly for best protection, whether due to a lack of resources or a lack of knowledge (Figures 119 and 120). This seemed

FIGURE 119 Temporary measures are important: this lateral brace is a good idea, but it is too slender and there is only one.

to be particularly true of lateral bracing, which is less intuitive to most people than vertical shoring. Training would improve the safety of this work. Also, it may be helpful to establish a group of contractors and assist them in securing shoring materials and equipment. In general, the team found that shoring should consist of timber (or other material) members leaning diagonally against a vertical wall to counteract the overturning action or placed vertically beneath a structure where the original bearing members or walls had been compromised. Other materials that are missing or in short supply include adjustable steel columns with threaded steel extensions, and polypropylene straps that can be wrapped around a structure. For examples of post-earthquake shoring in Italy, see Figure 121 and also: <http://haiti-patrimoine.org/wp-content/uploads/2010/02/ItalianShoring-MoliseEQ.pdf>

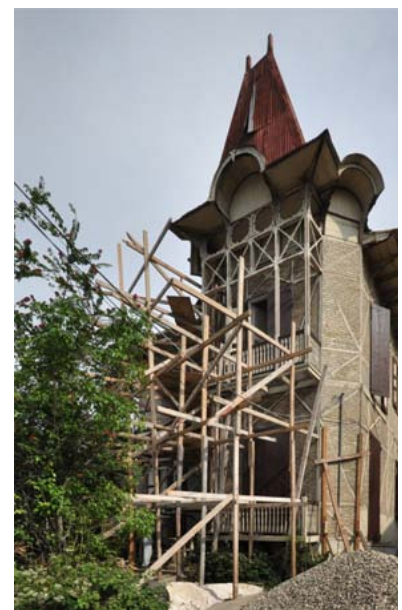
FIGURE 120 Scaffolding and shoring at 32 Lamartiniere, and shoring on the interior of 22 Rue Pacot.

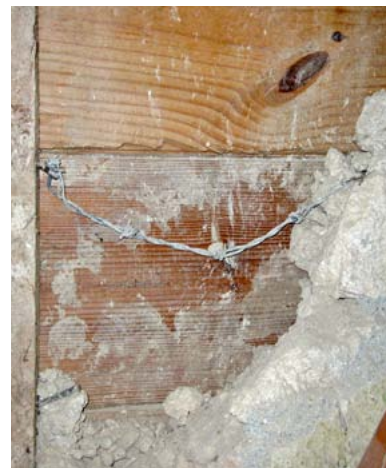
FIGURE 125 Barbed wire is frequently seen in the wall cavities as a restraint for the rubble fill. This is a good practice and should be continued.

- There is evidence in a few houses that the rubble stone infill masonry was reinforced with barbed wire at the time of the original construction. Continuing this tradition when rubble infill is reconstructed is advisable (Figure 125). Other types of mesh, including plastic geogrid, could be explored as a reinforcement, but barbed wire may be ideal for the following reasons: (1) it is widely available in Haiti for farming purposes, as well as security fencing, (2) it is almost always galvanized (which is essential if it is to be used for permanent construction), (3) it can be easily installed as the masonry construction is laid up. It is, however, recommended that a different configuration for its layout be used so as to improve the reinforcement effect. Historically a zigzag layout was used. If it is installed primarily as a horizontal bedding reinforcement with some strands crossing over the exposed exterior surface of the masonry (behind the plaster finish), then it can better hold the masonry in place.

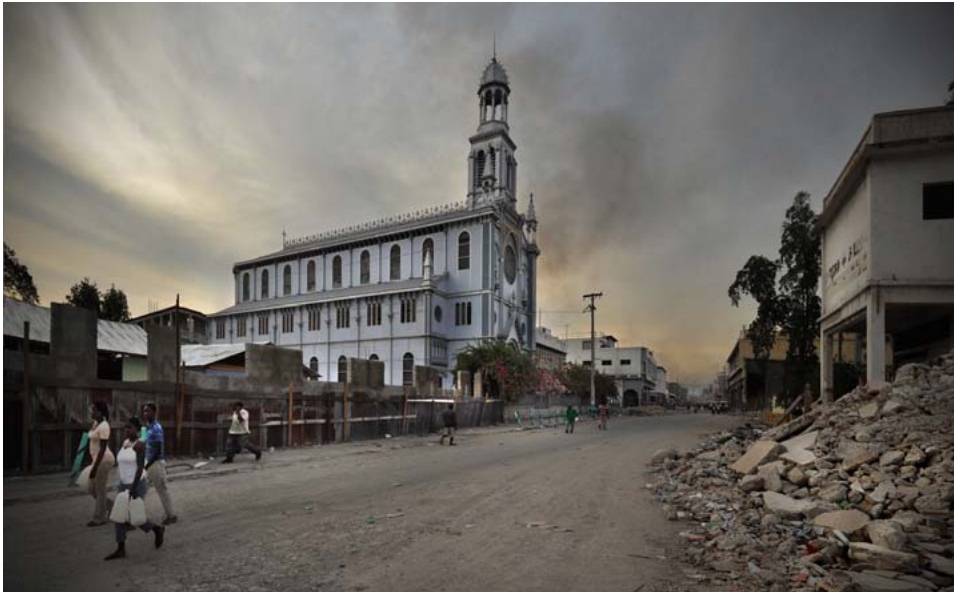
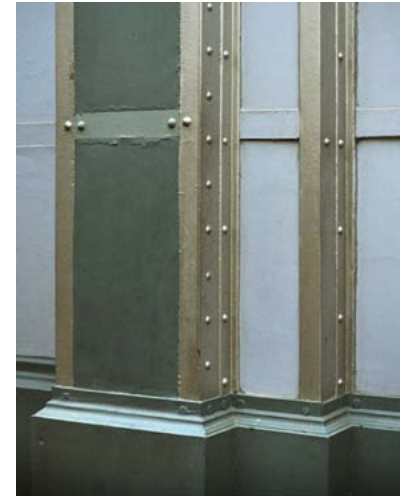
FIGURE 133 Saint Louis de Gonzague Chapel on Rue Du Centre after the earthquake. While the modern buildings of the Roman Catholic School collapsed, the Saint Louis de Gonzague Chapel survived without major damage. The Brothers of Christian Education founded the School in 1890, and the Chapel dates from after that date. This chapel is as large and tall as the nave of the Cathedral had been. Its iron frame, which serves to confine the masonry walls, was prefabricated in France. This structural system proved remarkably resilient compared to the early reinforced concrete construction found in the Cathedral as well as the National Palace.

- Surface-applied steel reinforcement like that seen in the Saint Louis de Gonzague Chapel, and the small chapel next to the Cathedral (Figures 131, 132, 133), has performed well in the Haiti environment, probably because of protective coatings and subsequent application of paint. This kind of strategy can be considered, especially where the floor level chains are missing or corroded, and replacing them *in situ* internal to the wall is not possible. The remarkably good performance of those two churches could be considered an inspiration and a model for good performing masonry construction.

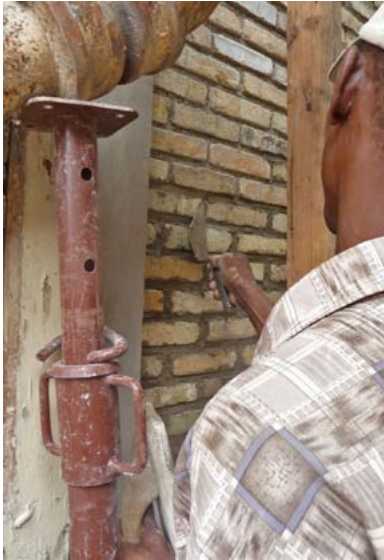
FIGURE 134 The modern reinforced-concrete frame with concrete-block back additions to the house at 24 Avenue Lamartiniere collapsed in the earthquake and have been removed. The owner, architect Gilbert Mangones, is now doing all of the repairs with timber framing and cladding, which will be much more compatible with the flexible timber frame of the original house, and less likely to collapse in a future earthquake.

To the extent possible, additions should be constructed of materials and structural systems compatible with the original house (Figure 134). Any additions not constructed of the same material and structural system of the original house—particularly when they will have a different lateral stiffness—should (1) be designed and engineered as separate structures with their own seismic system, rather than relying on the existing structure for either vertical or lateral support, and (2) be separated from the existing structure with a seismic joint. The seismic joint needs to be sized for the expected sway of both structures to avoid pounding, so that the two structures will not strike against each other during any future seismic event. It is recommended that a structural engineer be consulted to determine the size of this joint, and on the design of the floor and enclosure system on both sides of the joint. The joint can be bridged so that there is no gap in the weather enclosure of the house with its addition.

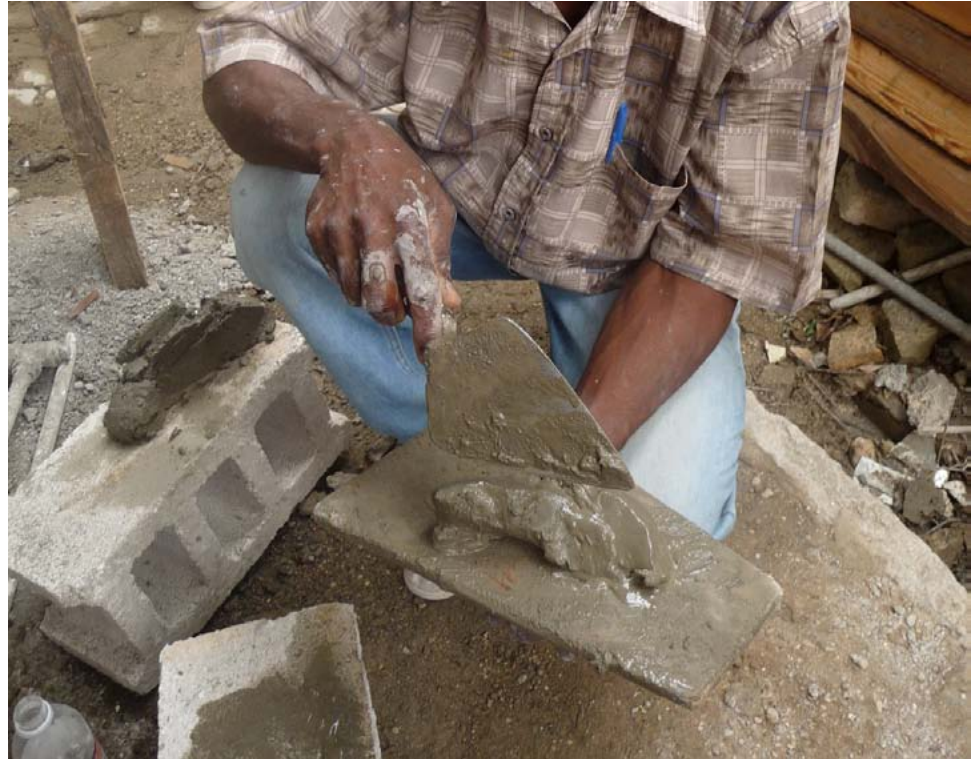
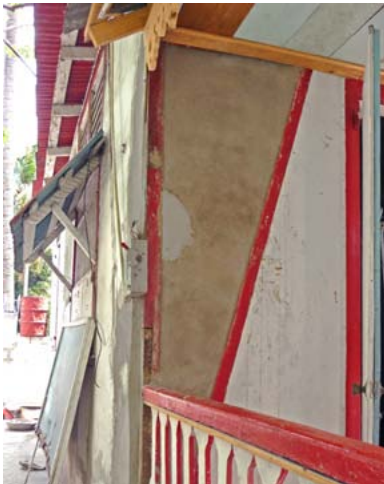
FIGURE 135 Well-intentioned but improper repairs with cement mortar in brick work (*above and right*), and cement plaster for colombage infill (*below*). Lime mortar and lime plaster should be used.

- ❑ In all repairs, care should be taken to avoid the use of strong Portland cement mortar. Ideally, hydrated lime should be used (which may need to be imported). If lime mortar is not available, it may actually be better to use clay mortar than to use Portland cement mortar, if the existing mortar for the surrounding brickwork is of similar strength and consistency as clay mortar. There are two primary reasons for this approach: (a) Portland cement mortar is too strong, rigid and brittle, such that the repaired section of the wall will act as a stiff plug, attracting all of the shear forces not only from earthquakes but also from wind, thermal expansion, and differential settlement leading to cracks in the wall, and (b) Portland cement can infuse the surrounding low-fired brick masonry with soluble salts, leading to its rapid erosion and exfoliation.

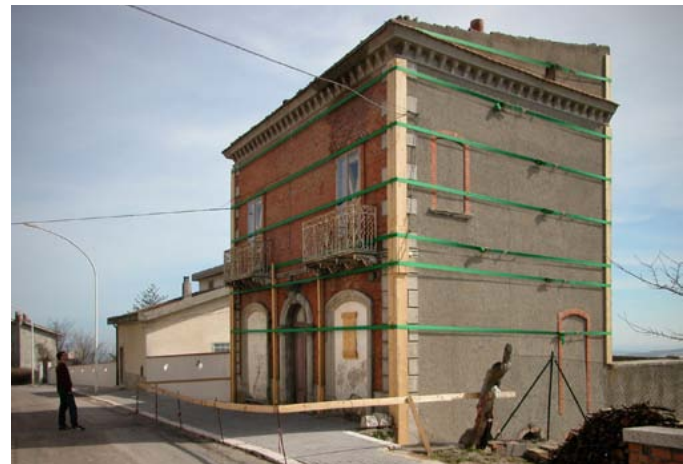
FIGURE 138 Examples of shoring constructed after the two recent earthquakes in Italy demonstrate different solutions to the important problem of stabilizing heritage structures to avoid emergency demolition for public safety. The two photos on this page show an unreinforced masonry building damaged in the 2002 Molise earthquake shored entirely with polyester straps, thus eliminating the need to block the street with diagonal braces. Shoring has been installed in the window openings—an important part of any system as it gives the damaged masonry wall structural continuity across openings.

There are numerous strategies that can be used to mitigate damage to the building. The strategies discussed below are not utilized in isolation but are used as a complement to one another as dictated by specific circumstances (Figure 138, following page).
